Address, Bismarck, ND  
Inspection prepared for: Sample Report  
Real Estate Agent: -

Date of Inspection: 1/29/2020 Time: 3:00 PM  
Age of Home: 1971 Size: 2460  
Weather: Cloudy 28 degrees

## Report Summary

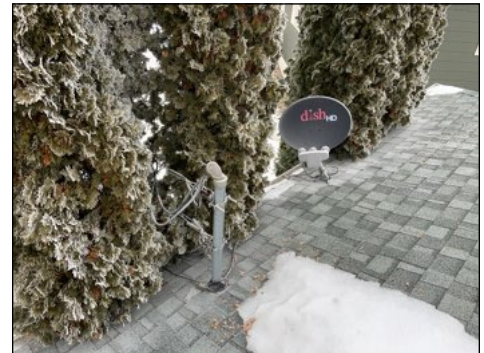
Once tress are removed, debris on shingles won't be an issue.

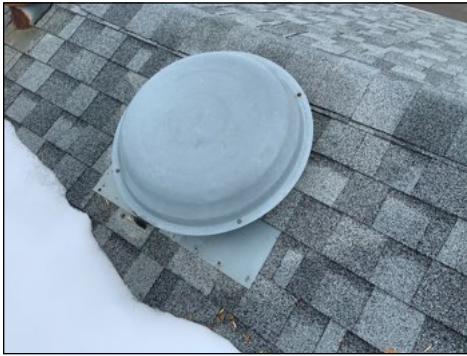
Consider replacing due to hail damage and rust.

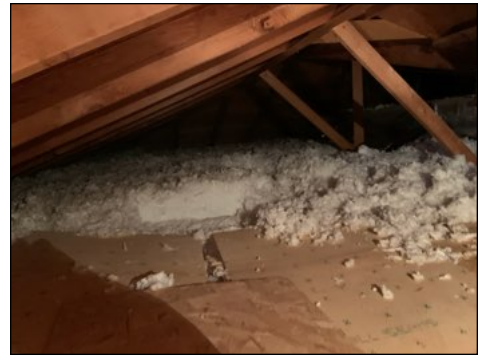
Trampled insulation may contribute to cracking in hallway ceiling below. Recommend releveling insulation.

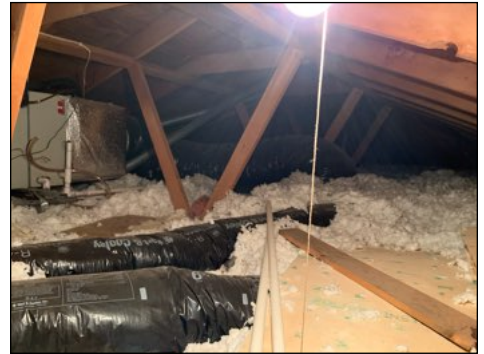
No baffles present. Ventilation appears adequate.

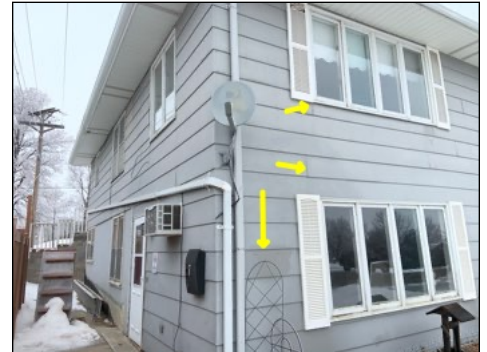
Discolored siding, unsealed joints. New siding will repair areas like this.

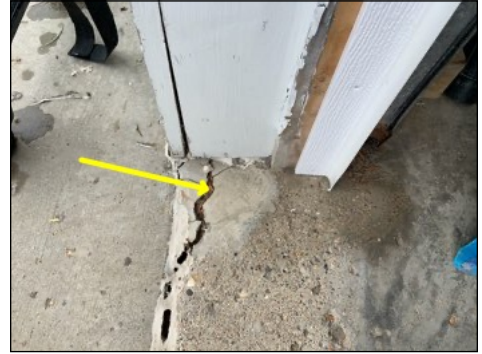
Driveway is heaved compared to garage due to moisture under it. Recommend sealing joint between slabs.

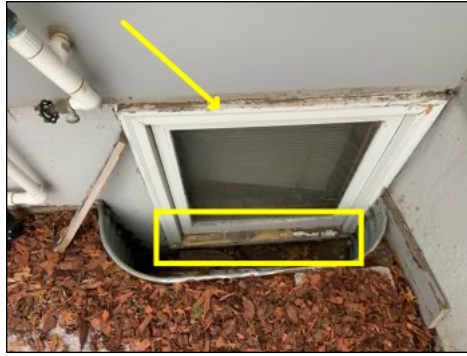
Recommend flashing be installed on top of windows when new siding is installed. Recommend repair of damaged sills, priming and painting.

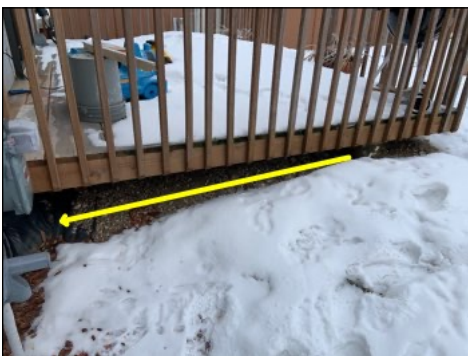
Landscaping under deck slopes toward home. Recommend creating swale in front of deck to divert water away from home.

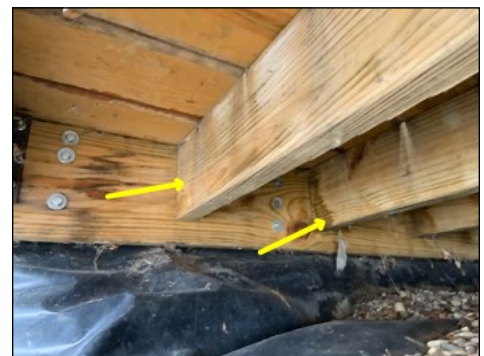
Recommend joist hangers be installed on ledger board.

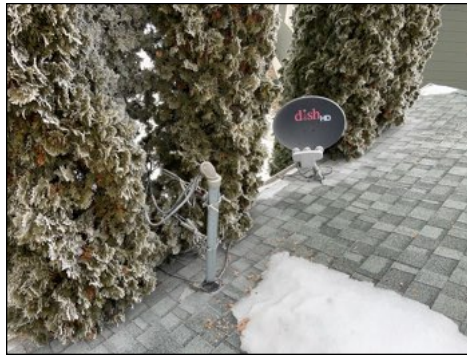
Trees have overgrown soffit and deposit debris in gutters and on roof. Recommend removing trees.

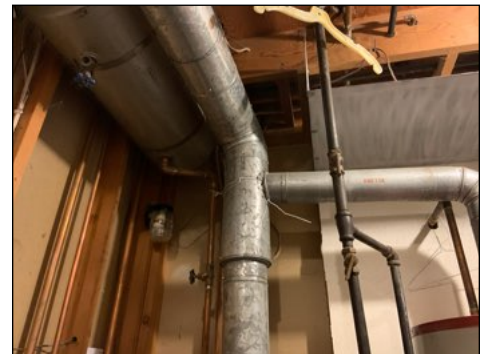
Improper seal. Recommend repair by HVAC specialist.

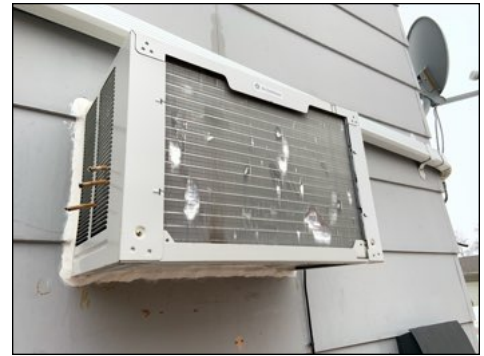
Recommend combing out fins.

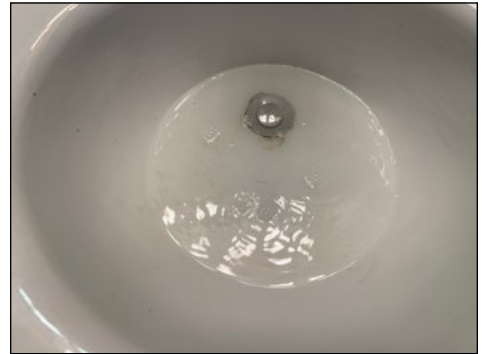
Slow drain upstairs main bat.

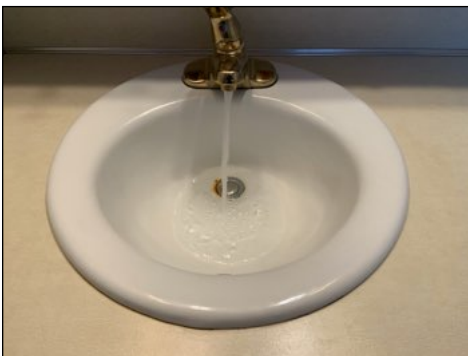
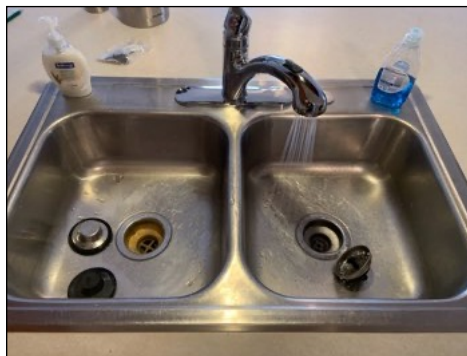
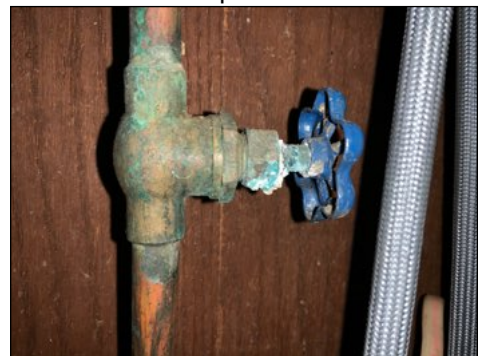
Corrosion on valves upstairs. Consider replacing with 1/4 turn valves.

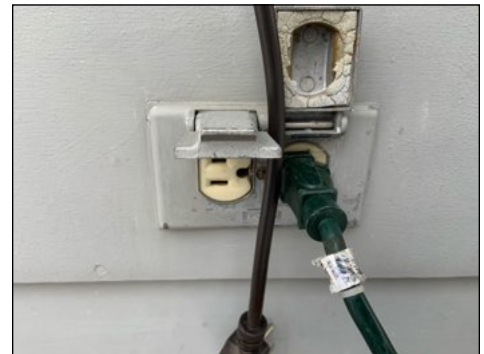
No GFCI in upstairs kitchen, baths, exterior and garage.

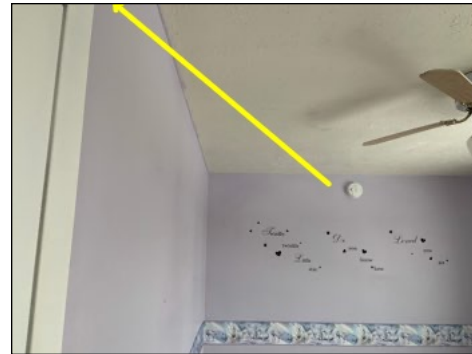
Recommend ceiling mounting detectors to main entrance of rooms.

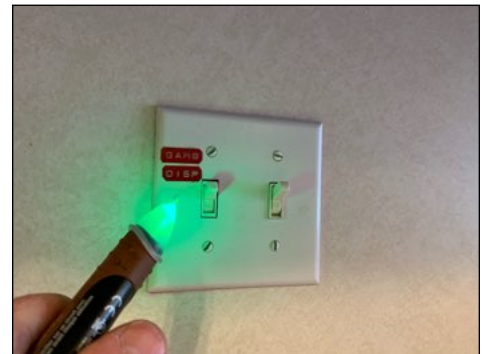
Recommend terminating wire under upstairs kitchen sink in a covered box.

Switch activates loose wire under sink.

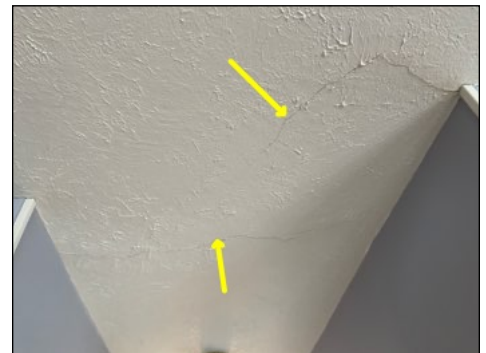
Upstairs hallway ceiling cracking. Recommend releveling insulation in attic above prior to repair as this is most likely caused by uplift due to lack of insulation in this area.

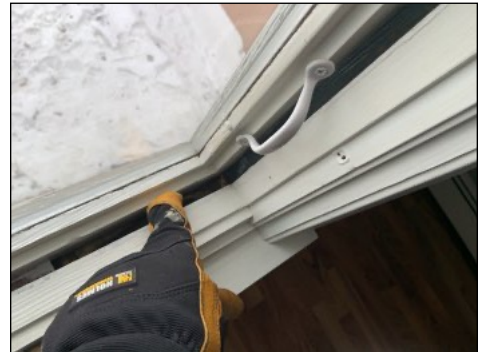
Note all bedroom windows have smaller size openings than modern standards of 5.7SF.

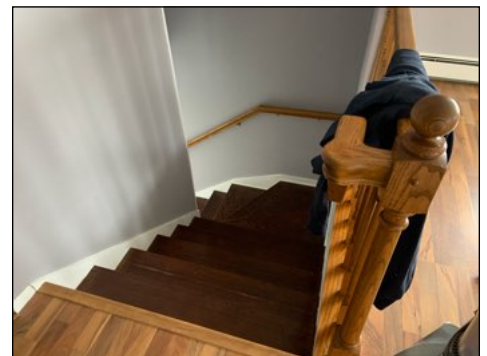
Loose Newell post upstairs.

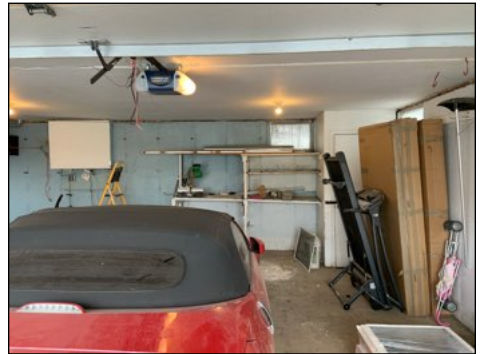
Recommend repair to penetrations in firewall.

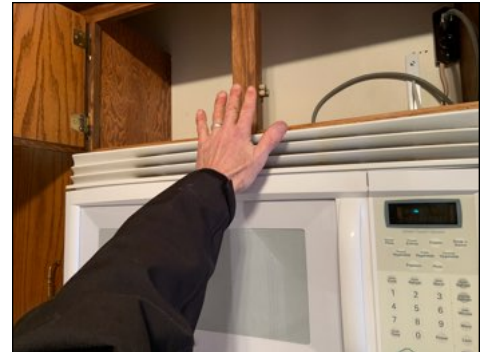
Recommend installing smoke/grease combination filter upstairs

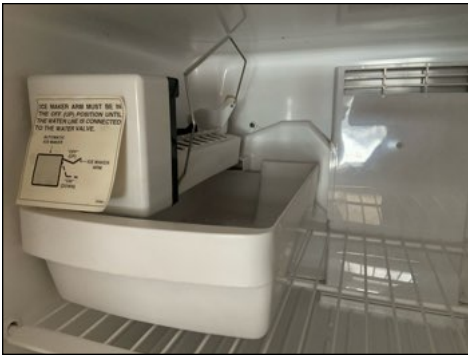
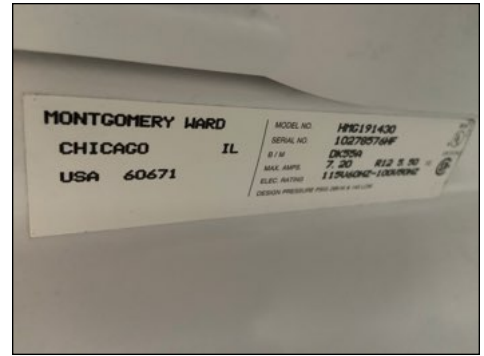
Refrigerator downstairs did not cool effectively. Recommend repair.

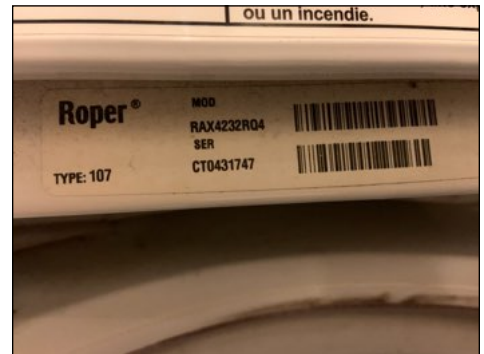
Recommend installing metal braided hoses downstairs.
