Address, Bismarck, ND  
Inspection prepared for: Sample Report  
Real Estate Agent: -

Date of Inspection: 1/29/2020 Time: 3:00 PM  
Age of Home: 1971 Size: 2460  
Weather: Cloudy 28 degrees

## Report Summary

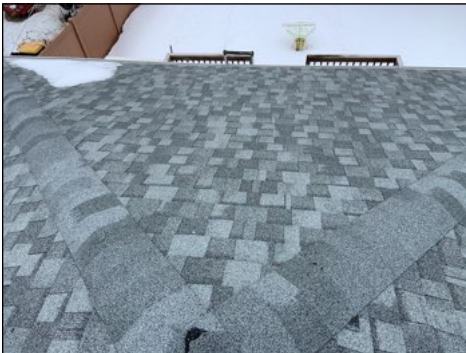
South slope of home.

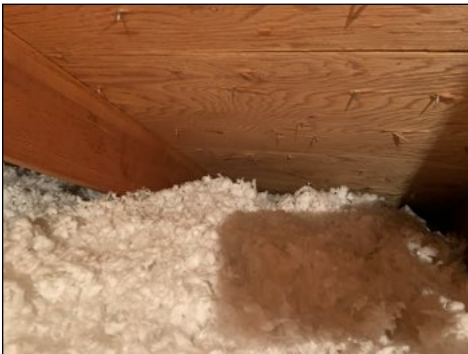
No baffles present. Ventilation appears adequate.

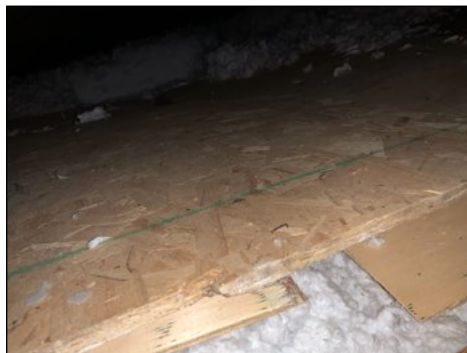
6.1. The attic access scuttle hatch was poorly installed. You should have this repaired or replaced by a qualified tradesperson.

Recommend adding insulation to scuttle hatch.

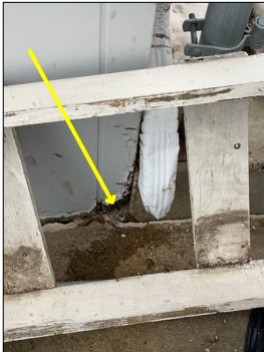
1.1. There was damage to the siding which can allow moisture intrusion and should be repaired. Location: various locations. Understand current owner will install new siding.

Masonite siding damaged on north side of garage. Recommend repair.

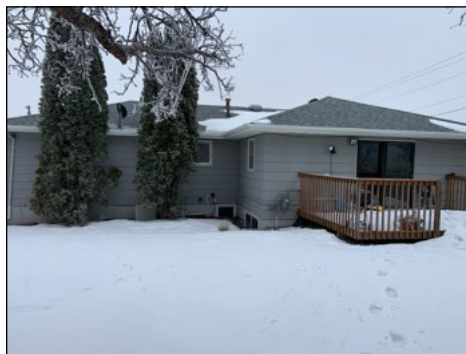
Rear of home includes a deck and main utility entrance. Recommend resloping landscaping to flow away from foundation.

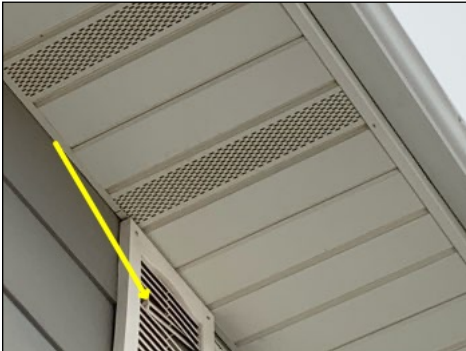
3.1. Damaged wood trim should be repaired as needed. Location: some damaged trim shutters and corner trim. Will be repaired when new siding is applied.

Damaged shutter on front of home. Will be removed when new siding is installed.

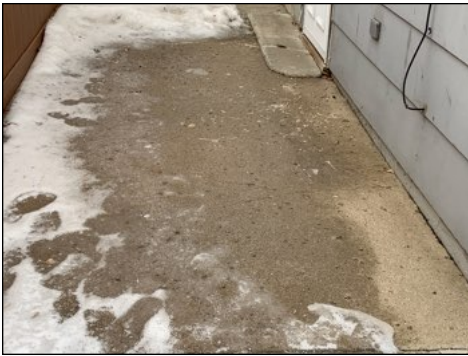
2" concrete repair step at side door.

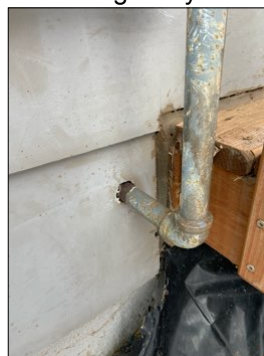
Deck attached directly to home as it should be.

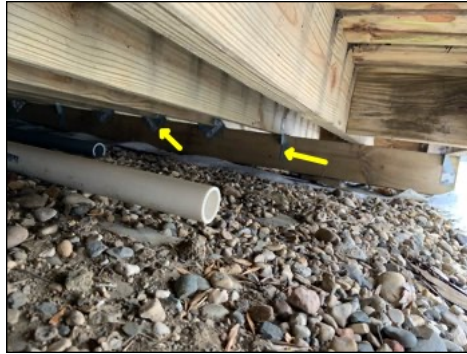
Proper clips installed on girder.

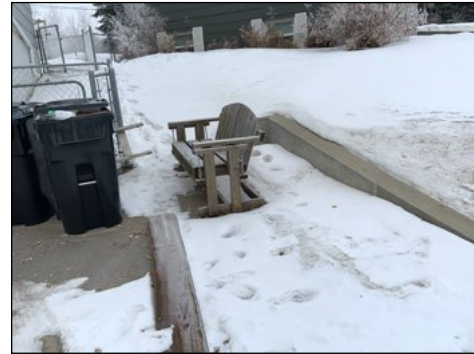
Small retaining wall up front to create a parking area.

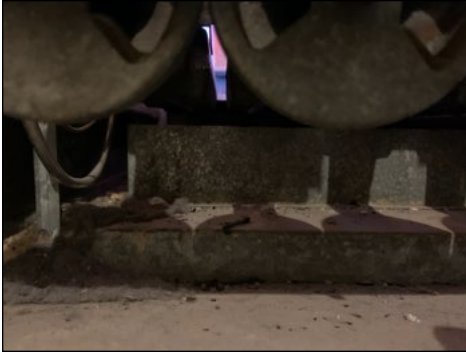
Corrosion in burn chamber. Recommend evaluation.

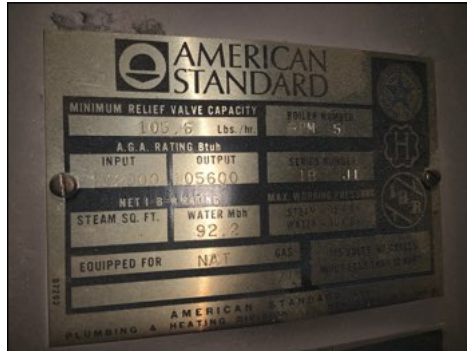
Appears to be original boiler.

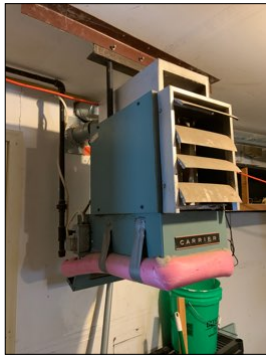
3.1. The garage heater setting was not in service.

Garage heater not in service.

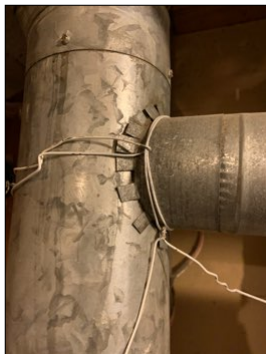
5.2. The gas water heater vent pipe connection to the furnace vent pipe should be a "WYE" and not a "T" type connection and should be corrected.

Improper slope and connection on water heater to boiler vent. Recommend repair.

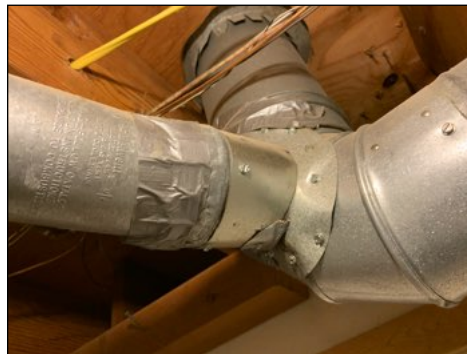
Improper seal. Recommend repair by HVAC specialist.

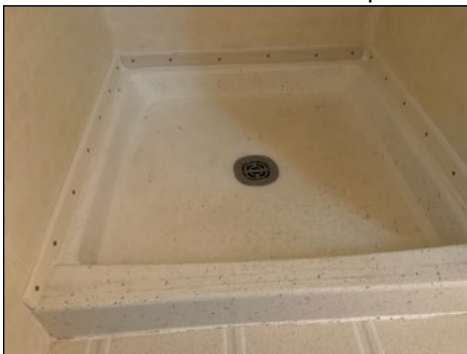
7.1. Failed sealant may allow damage from moisture intrusion of the wall assembly at a bathroom(s). The possibility of concealed damage exists. You should have repaired. Location: master bathroom upstairs and downstairs shower surround. Note this is not a recommended shower surround material. It is designed for flooring.

Leaking behind surround downstairs. Recommend immediate repair.

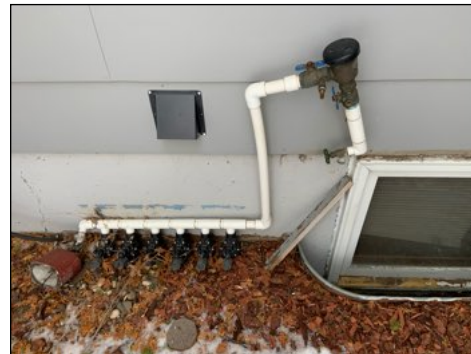
Manifold at rear of home. Recommend covering.

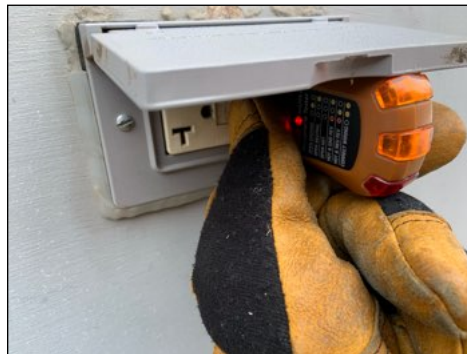
4.1. A GFCI did not trip when tested and should be repaired or replaced. Location: front exterior outlet.

Exterior front does not trip.

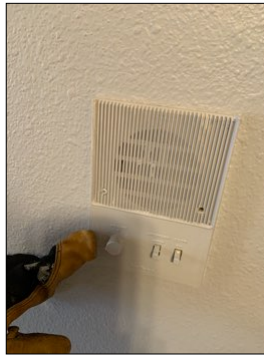
Intercom not operational.

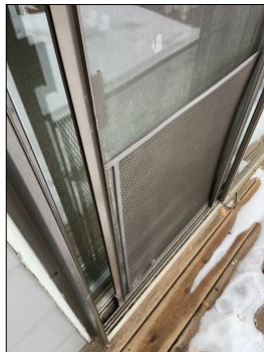
Rear screen door off track.

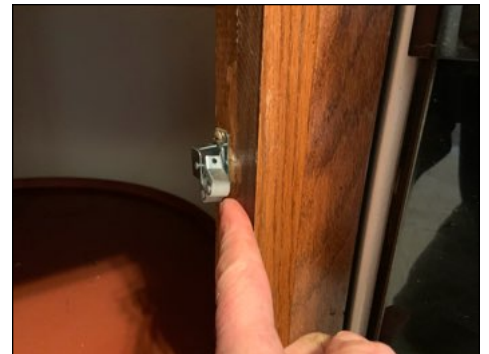
4.1. There was cabinetry that was not fully secured and should be repaired. Location: upstairs kitchen.

Latch not working upstairs kitchen corner cabinet.

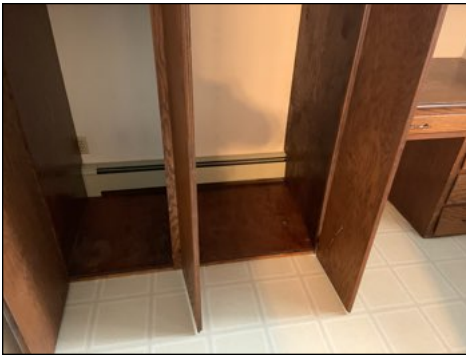
Note heat register behind cabinets in upstairs laundry. Poor heat distribution.

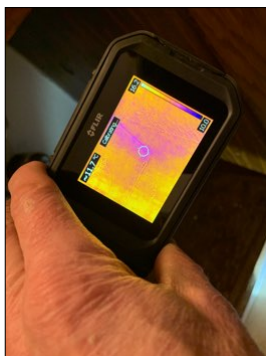
No elevated moisture under downstairs bathroom sink, or along bedroom foundation walls.

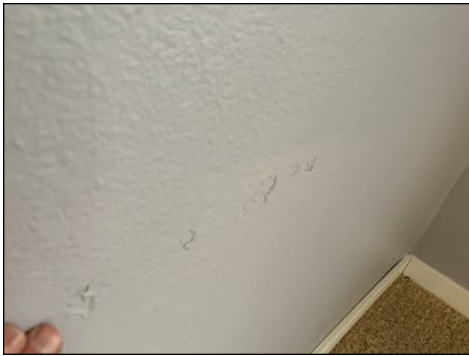
Slight wall damage upstairs

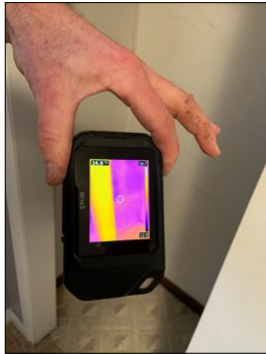
Closet downstairs has signs of past water issue, no elevated moisture nor visible microbial growth.

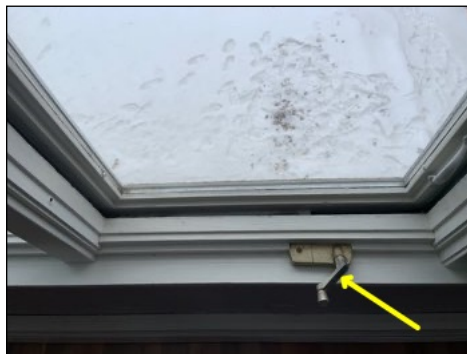
Some loose hardware.

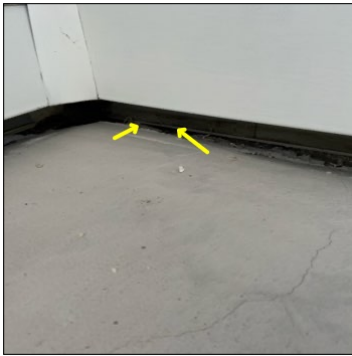
7.1. Uneven floors may have damage below the floor covering. A more invasive inspection would be required to determine the cause. Location: downstairs living room large heaving and sloped to SE corner of structure. Recommend exposing slab and having an engineer evaluate.

Up to 2" of patch material in downstairs living room subfloor.

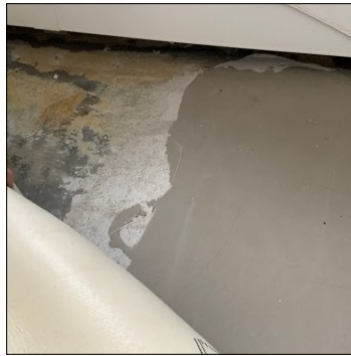
Floor leveler under carpet in downstairs living room.

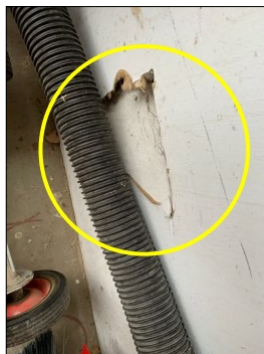
1.1. All garage separation wall penetrations should be appropriately repaired or sealed.

Recommend repair to penetrations in firewall.

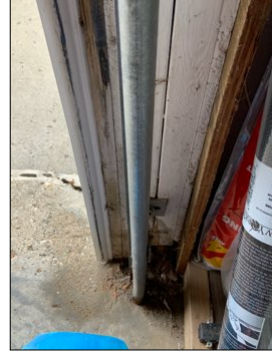
3.1. No photo sensors were installed, and should be installed for safety.

Missing safety sensors.
