Address, Bismarck, ND  
Inspection prepared for: Sample Report  
Real Estate Agent: -

Date of Inspection: 1/29/2020 Time: 3:00 PM  
Age of Home: 1971 Size: 2460  
Weather: Cloudy 28 degrees

## Report Summary

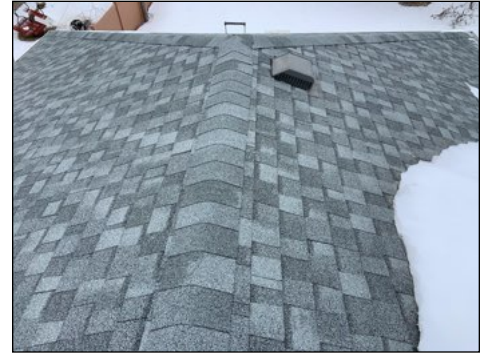
West slope of home. Note attic vent fan.

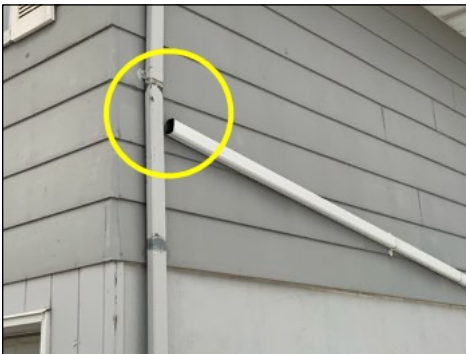
Note north gutter diversion not hooked up.

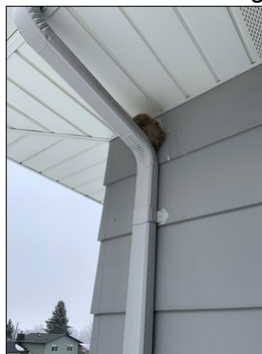
Nest ready for small birds in spring.

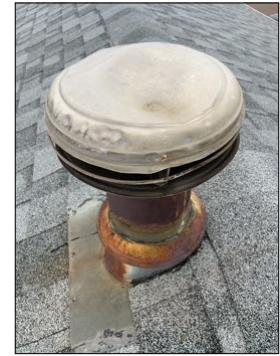
Consider replacing due to hail damage and rust.

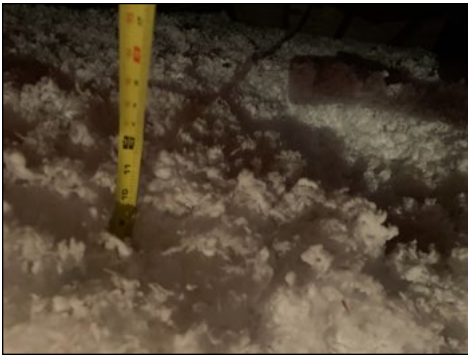
8-10" of fiberglass on top of R19 is very good insulation.

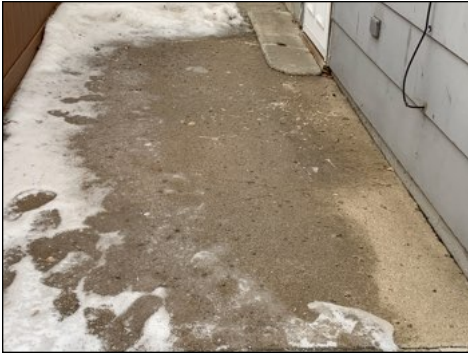
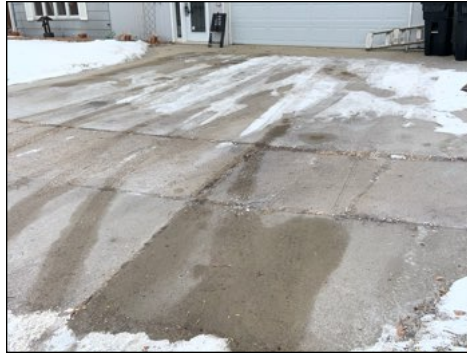
2.1. Normal cracking was present with no significant deficiencies.

Recommend sealing all cracks and joints with self leveling concrete seal.

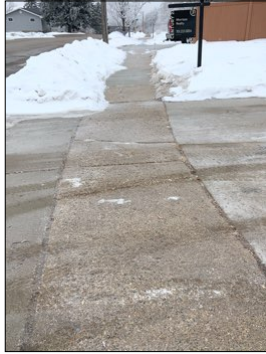
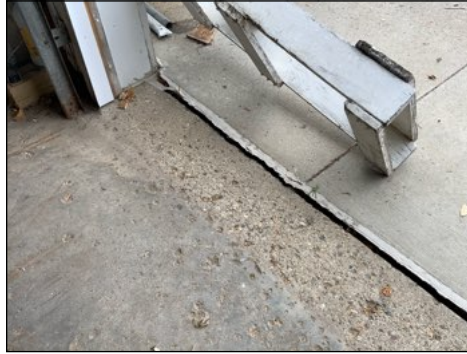
Driveway is heaved compared to garage due to moisture under it. Recommend sealing joint between slabs.

Concrete patch where drive meets garage.

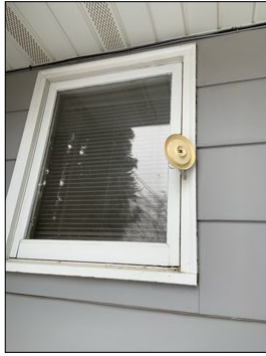
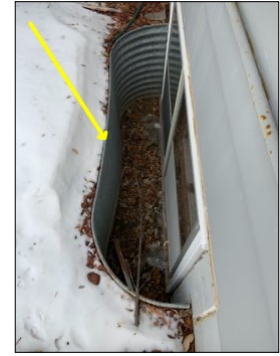
4.1. Damaged wood at windows which should be repaired or replaced. Location: sills on most windows. South lower window in kitchen to be replaced prior to new siding being installed.

Pressure on window well. Recommend covers for window wells.

Recommend flashing be installed on top of windows when new siding is installed. Recommend repair of damaged sills, priming and painting.

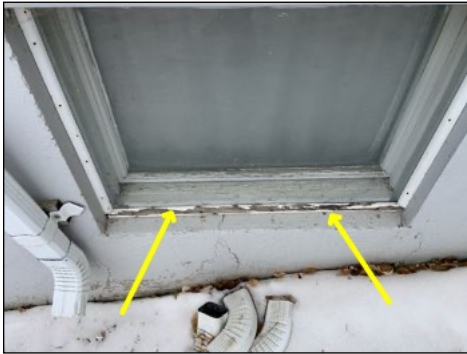
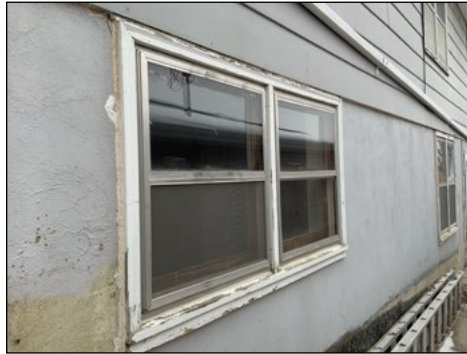
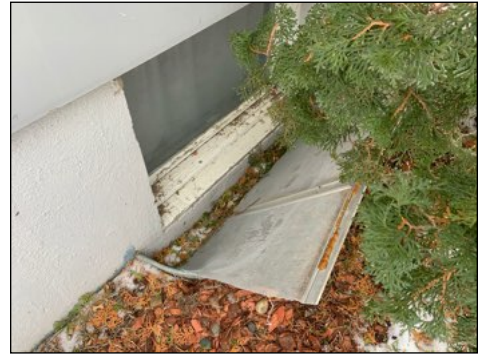
Garage windows have been covered from inside.

Chipping and peeling paint. Warning could contain lead.

Screen fallen off on NW corner garage window.

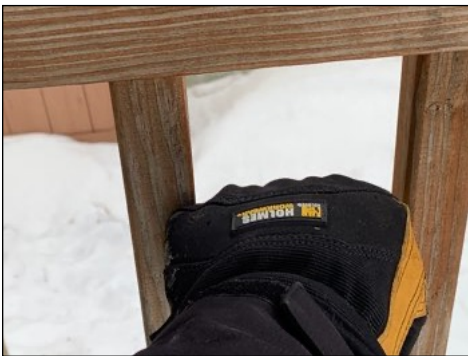
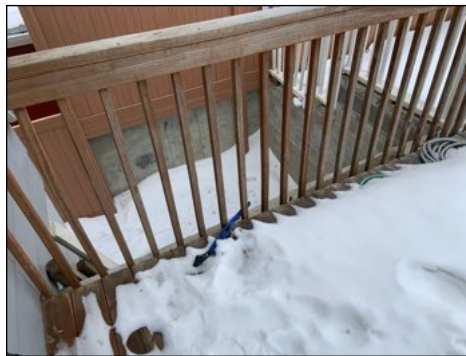
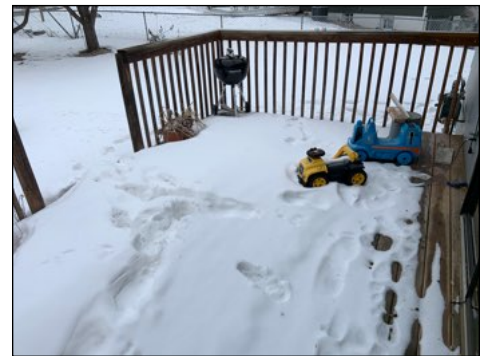
Finish coat degraded. Recommend staining this year.

Deck 90% covered with snow.

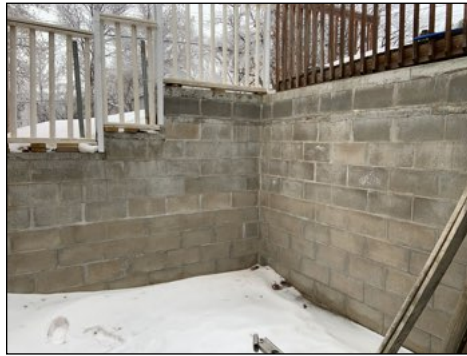
7.1. FYI: The patio was covered snow. A visible inspection was not possible.

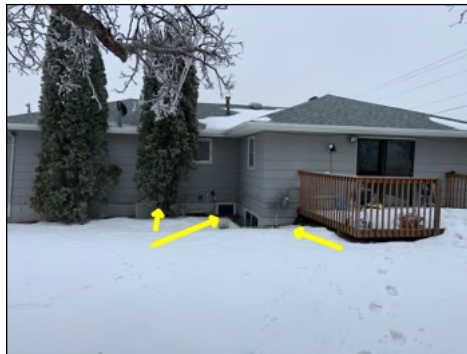
8.1. The property grade was negative in areas. If ground slope correction is not possible you should consider other methods for drainage around the foundation. Location:

Areas where soil slopes towards foundation. No evidence of current water intrusion, recommend creating a swale to divert water away from home.

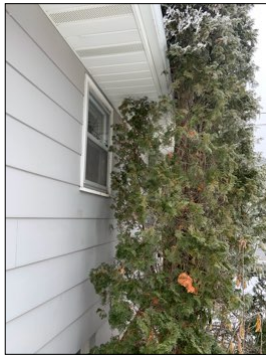
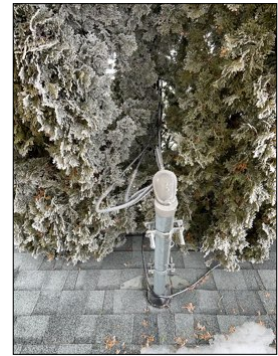
9.2. Vegetation growing against the exterior walls which should be removed.

Trees have overgrown soffit and deposit debris in gutters and on roof. Recommend removing trees.

No clearance available for electrical service. 24" is required. Recommend removing trees at rear of home.

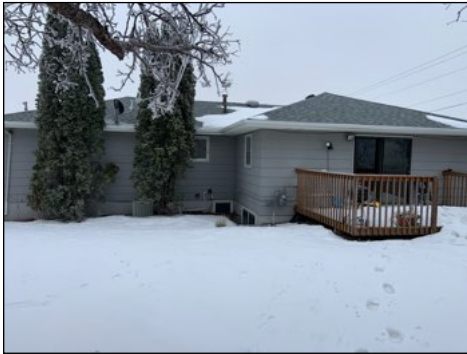
Planter bed had trees in past. Roots may contribute to heaving in downstairs slab.

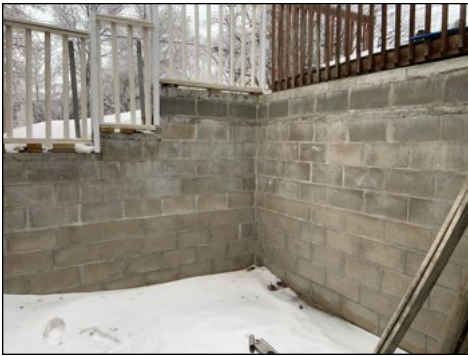
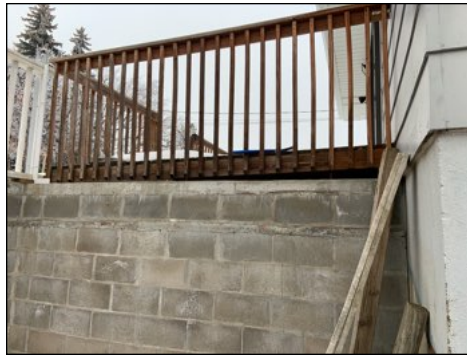
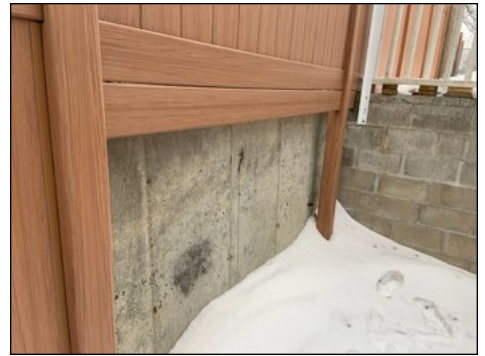
South retaining wall in acceptable condition. Monitor as no weep drains are present.

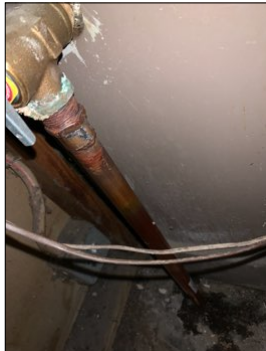
Leaking pressure relief on boiler.

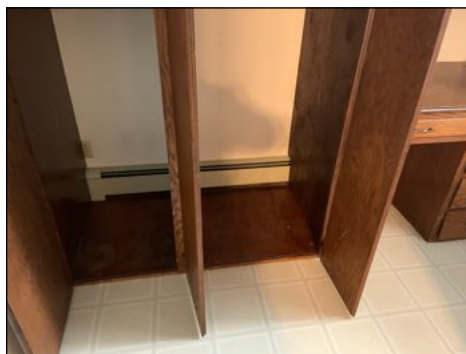
9.1. No deficiencies were observed. The interior condition of the ductwork is beyond the scope of a home inspection and would require a more invasive inspection if this condition is a concern. Note upstairs laundry has register in closet. Improper heat distribution

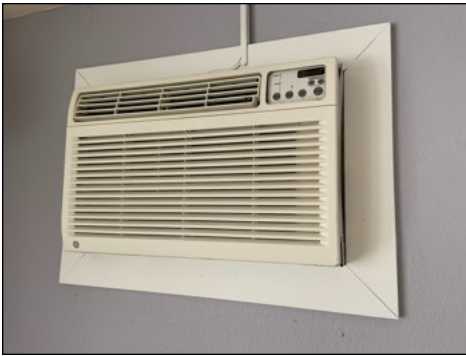
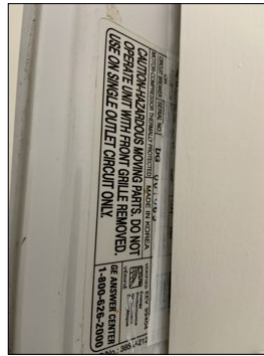
Recommend combing out fins.

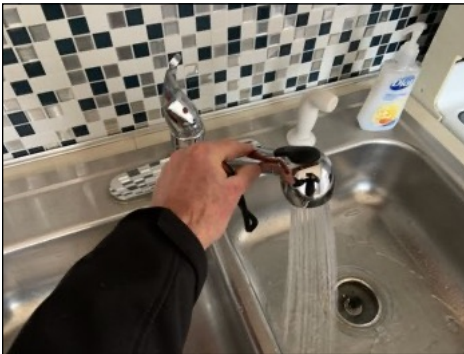
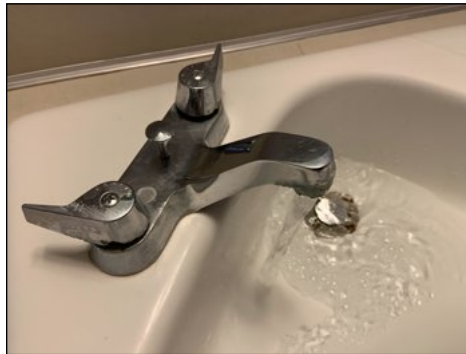
Recommend tightening downstairs kitchen faucet

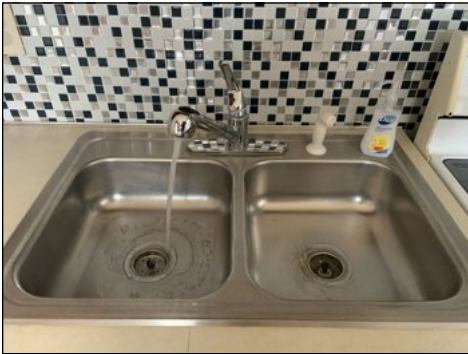
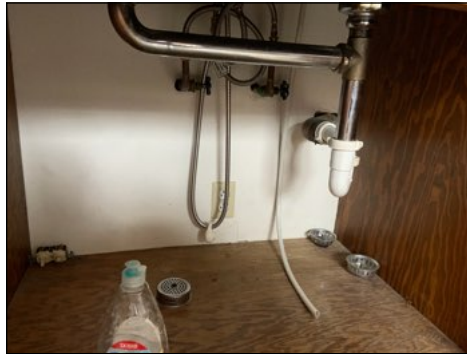
Slow drain upstairs main bat.

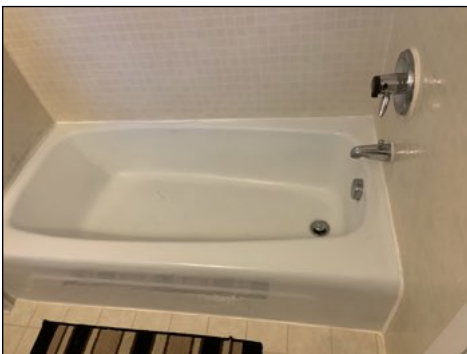
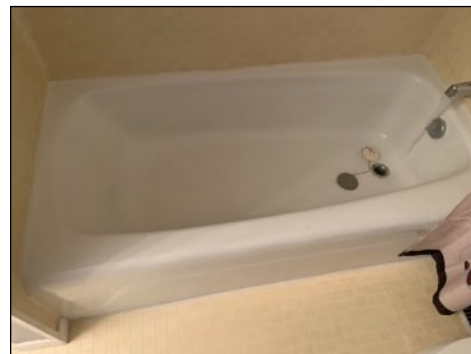
- 6.1. Tub stoppers that did not function should be adjusted or repaired. Location:

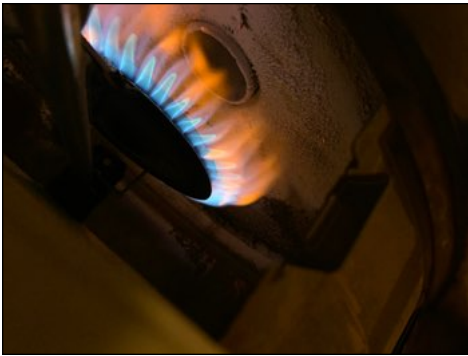
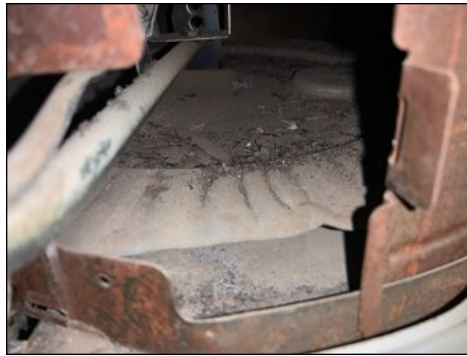
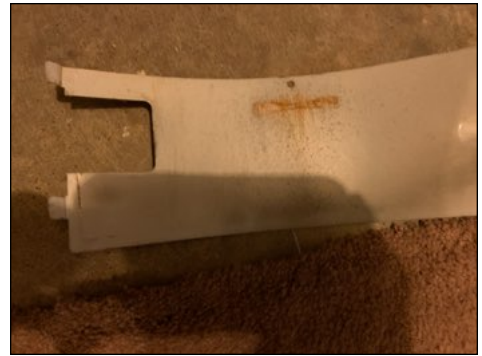
50 gallon conventional natural gas water heater located in garage was approximately 27 years old.

Corrosion in burn chamber.

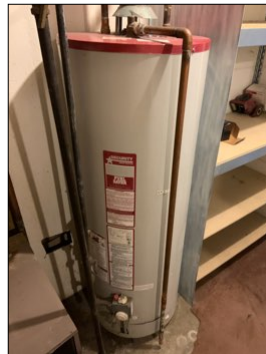
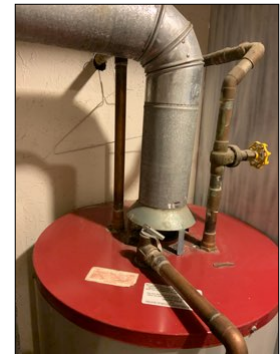
1993. At the end of serviceable, but no safety concern. Consider replacing in 1-3 years.

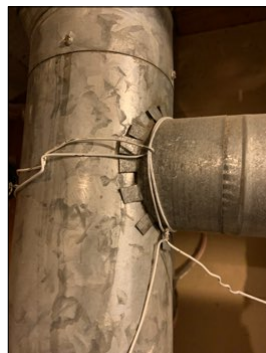
11.1. The water heater exhaust vent was installed improperly which can be carbon monoxide concern and needs repair.

Recommend repair.

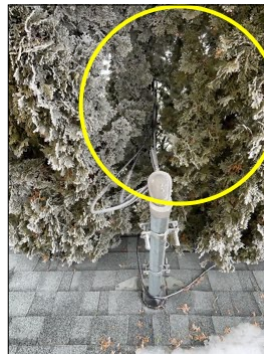
2.1. The overhead service-drop conductors had inadequate clearance from trees which is a potential shock/electrocution hazard and should be corrected.

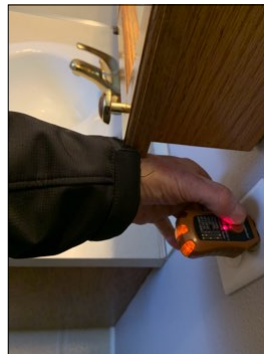
4.2. GFCI protection was not provided at locations where it is now deemed necessary for safety. It may not have been required at original construction, we recommend upgrading to have GFCI's installed at all recommended locations.

No GFCI in upstairs kitchen, baths, exterior and garage.

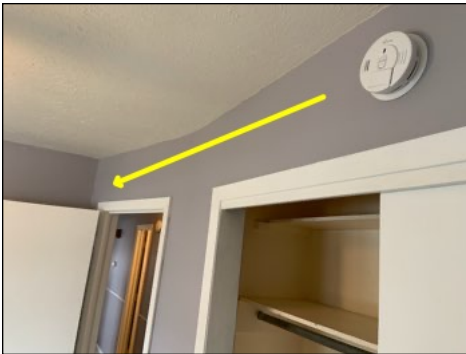
6.3. Recommend relocating detectors to main entrance of rooms. Recommend removing from kitchen areas.

Recommend ceiling mounting detectors to main entrance of rooms.

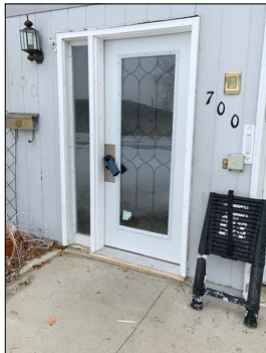
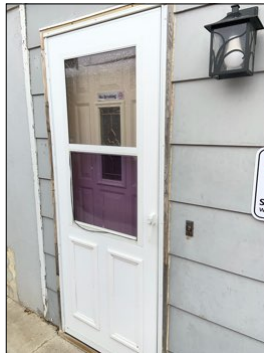
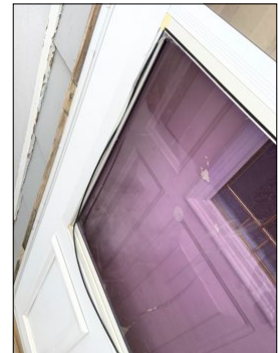
3.1. The exterior doors were functional. Storm door missing up front. Slight damage to side storm door.

Screen damaged on side storm door.

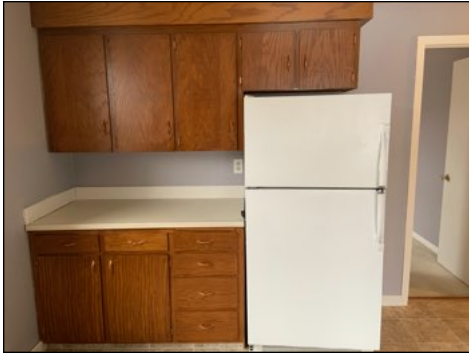
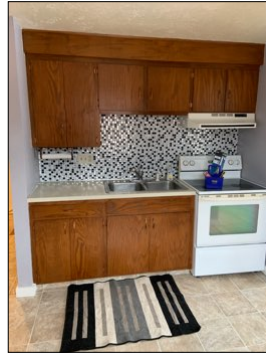
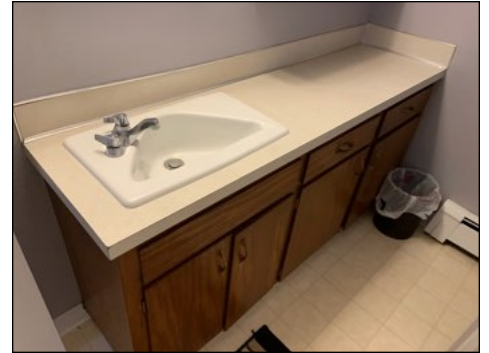
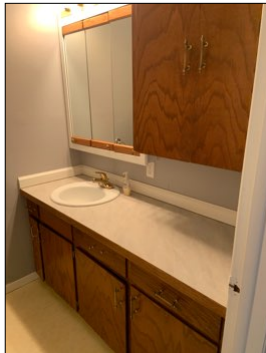
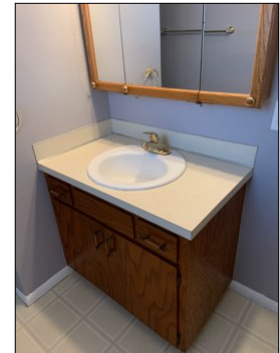
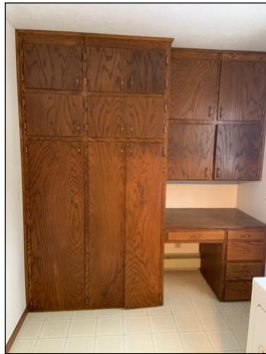
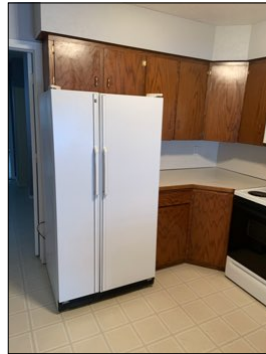
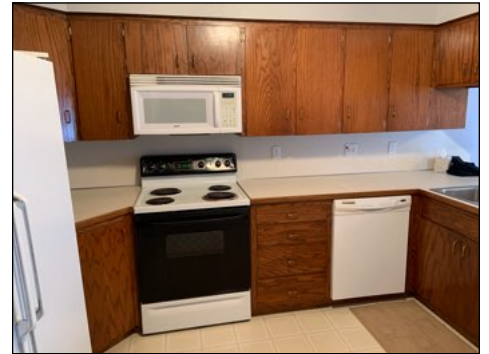
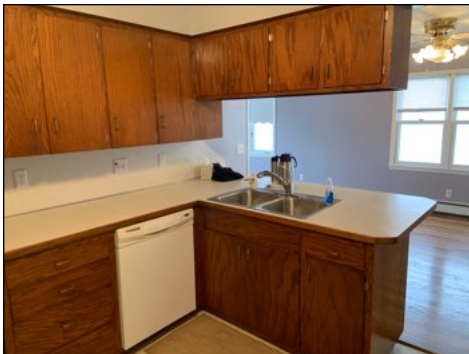
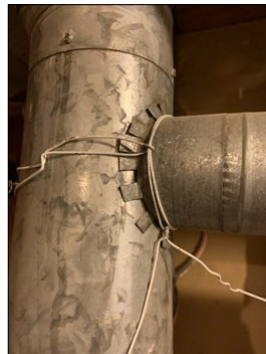
4.1. There was cabinetry that was not fully secured and should be repaired. Location: upstairs kitchen.

Latch not working upstairs kitchen corner cabinet.

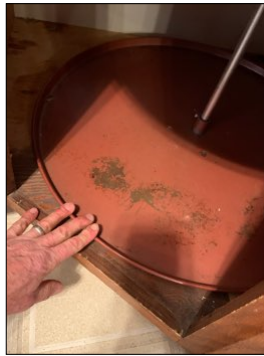
Lazy Susan bottom shelf not secured upstairs.

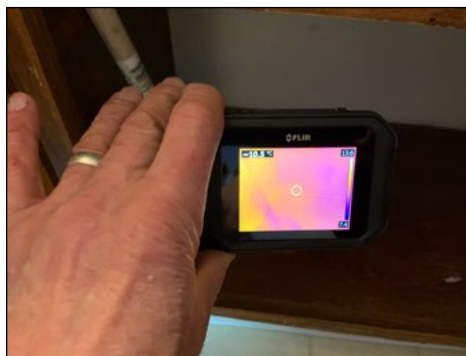
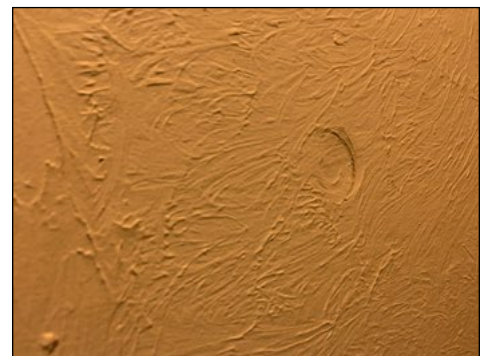
Door ding downstairs bathroom missing door stop.

8.1. Improve: There were missing door stops that should be installed to prevent wall damage.

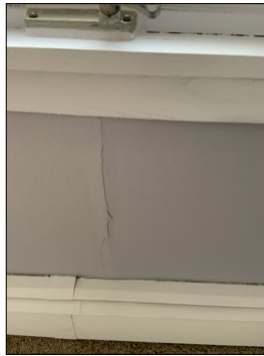
Seam cracks under and above windows and doors. Do not appear structural in nature.

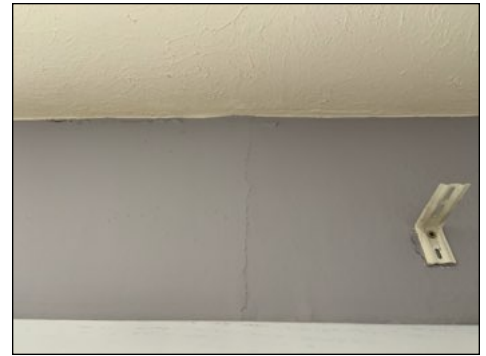
Closet downstairs has signs of past water issue, no elevated moisture nor visible microbial growth.

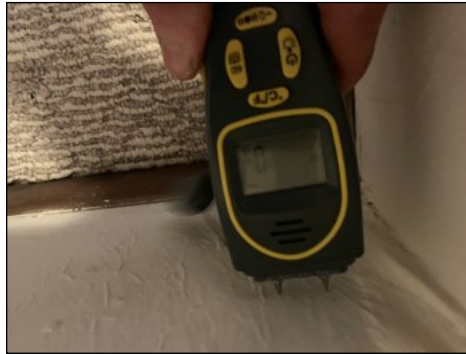
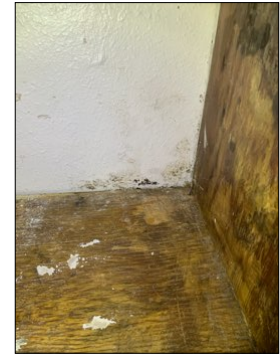
5.2. Damaged ceilings should be repaired as needed. Location: downstairs bath ceiling is swollen due to past water damage. Recommend replacing as it is deformed and may contain microbial growth.

Swollen and detached bathroom ceiling downstairs. Recommend replacing.

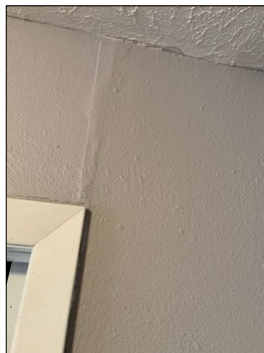
Upstairs hallway ceiling cracking. Recommend releveling insulation in attic above prior to repair as this is most likely caused by uplift due to lack of insulation in this area.

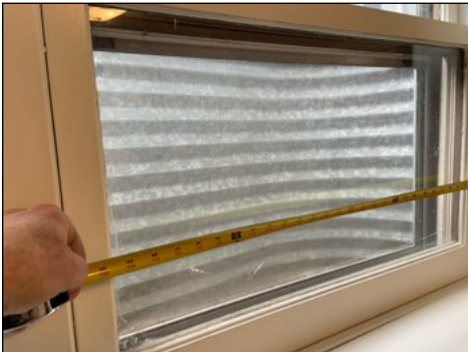
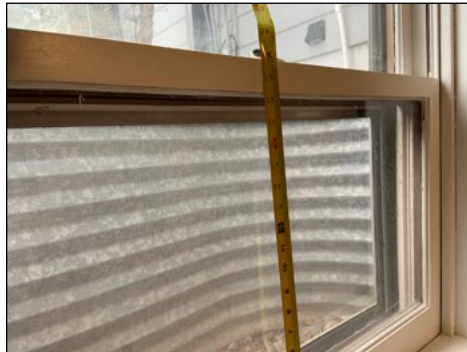
Note all bedroom windows have smaller size openings than modern standards of 5.7SF.

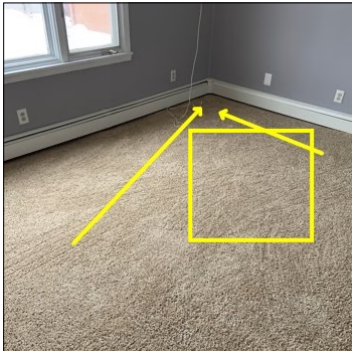
Floor sloped in this direction. Heaving in square. Recommend engineer evaluation. Does not appear to affect foundation.

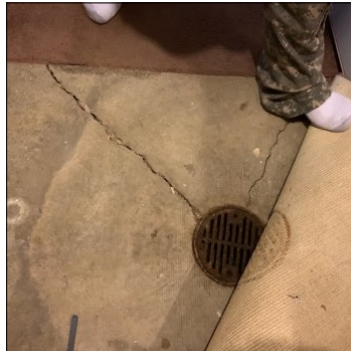
Slight cracking in slab in utility room. Recommend sealing.

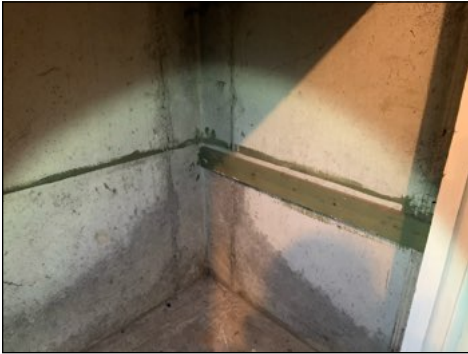
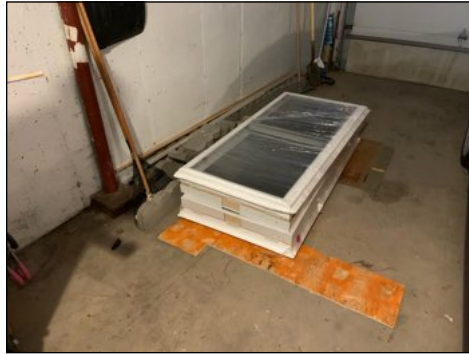
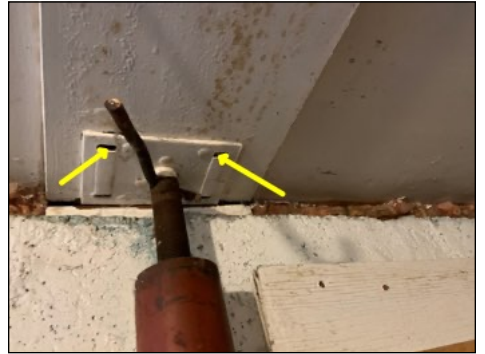
New downstairs kitchen windows stored in garage.

Recommend anchoring all posts.

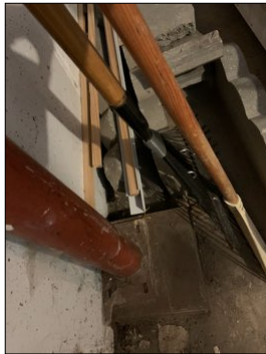
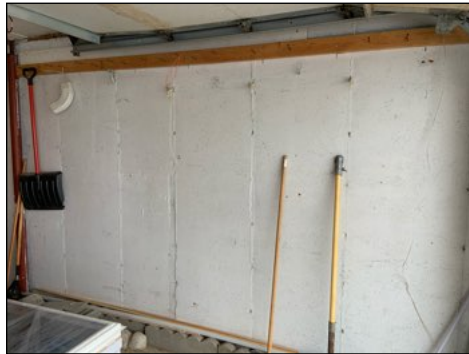
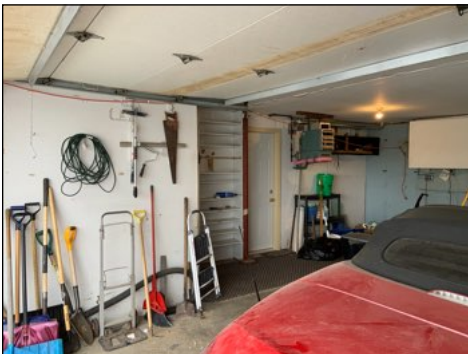
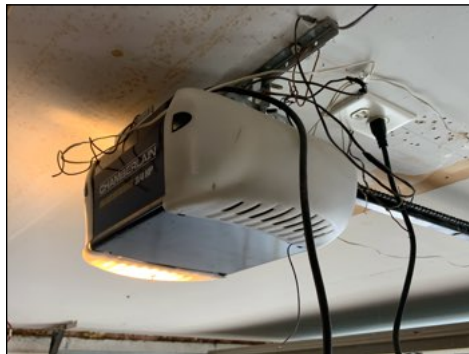
1.1. All garage separation wall penetrations should be appropriately repaired or sealed.

Recommend repair to penetrations in firewall.

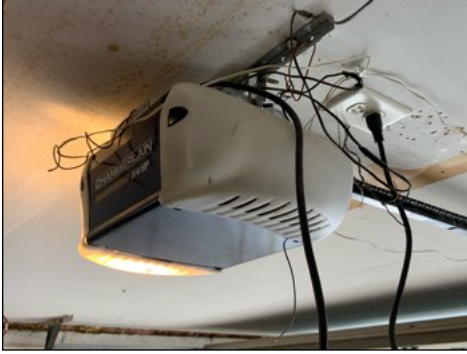
3.1. No photo sensors were installed, and should be installed for safety.

Missing safety sensors.

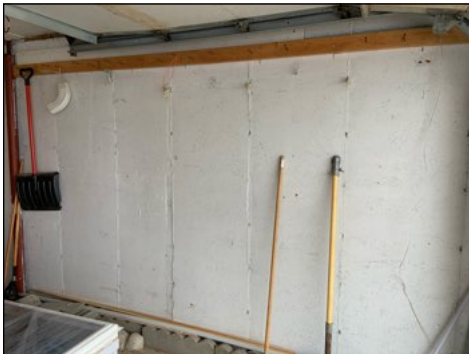
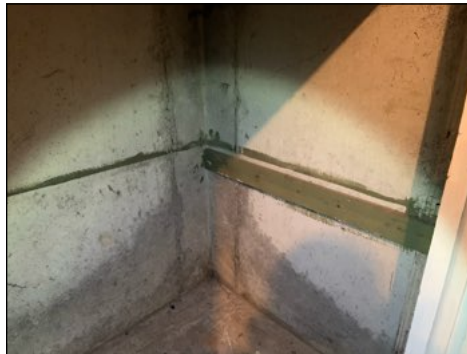
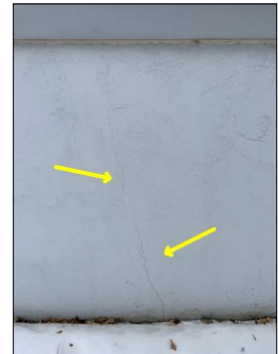
1.1. The foundation walls had small settling cracks visible on north wall of garage. Cracking should be patched to avoid freeze damage and the cause of cracking should be determined and corrected.

Recommend sealing small crack in north foundation wall.

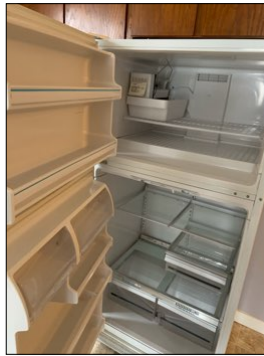
6.1. The refrigerator was operating during the inspection. We cannot determine the efficiency of the appliance. Downstairs fridge did not cool effectively.

Refrigerator downstairs did not cool effectively. Recommend repair.

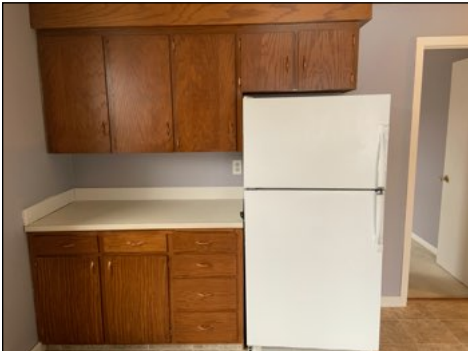
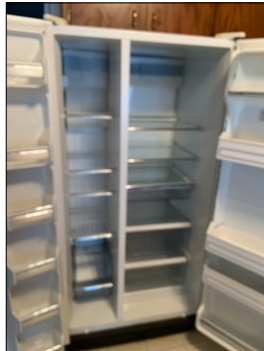
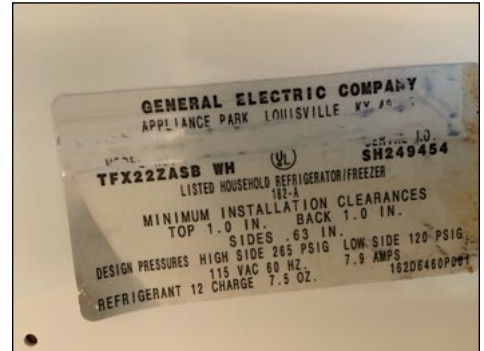
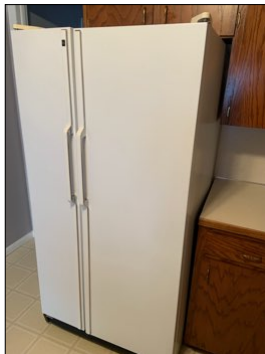
6.2. Improve: The water dispenser was not functional. It may not be installed correctly, turned on, or in need of repair.

Water line not connected upstairs, no water line downstairs.
